# City of Baltimore Wet Weather Consent Decree Smoke and Dyed Water Testing Form

Sewershed : Gwynn Falls

Manhole ID : S03UU\_026MH

Test ID : S1032-022010

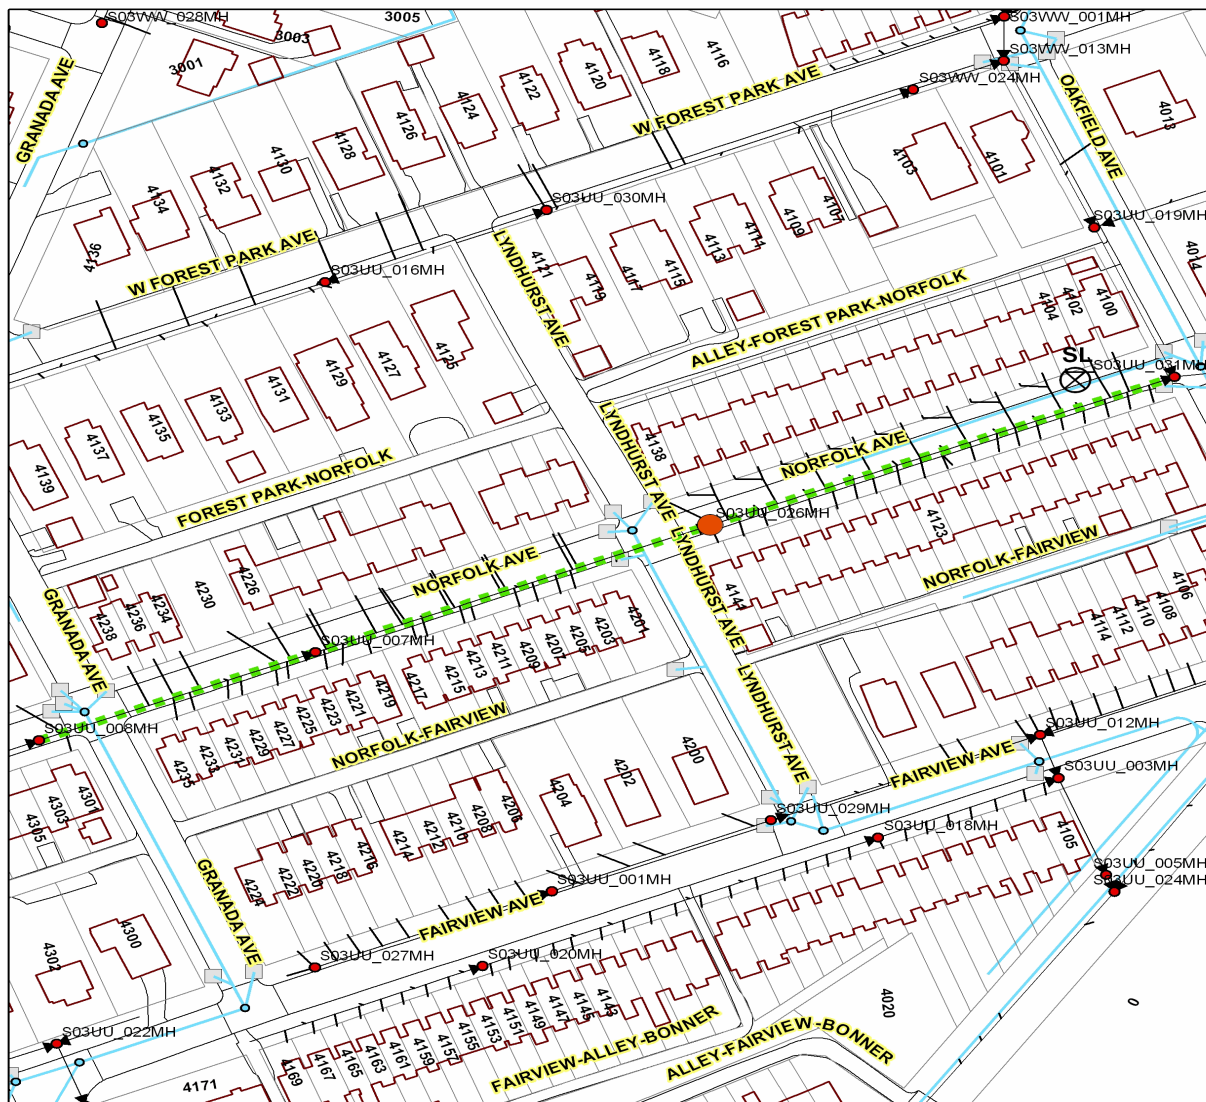
Field Sketch : (Show All Manholes with Numbers, Blower Placement Location, Sandbag or Isolation Locations, Street Names, Building Addresses and Locations, Defect Locations and Photograph Numbers)

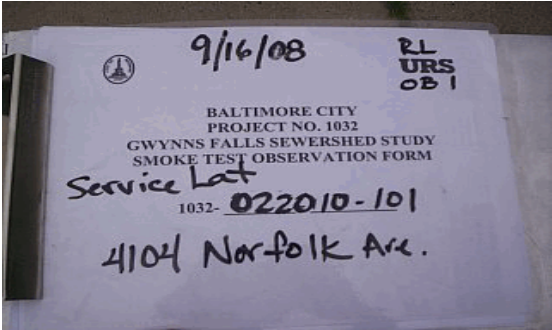
<p>Location: N/A; Type: Service Lateral; Smoke: Heavy; Status: Public ROW</p> </div> <div> Landscape
